*Re: TDHCA Application 26104 - Travis Street Plaza Apartments - Request for Waiver
Regarding Age Requirement*

Subject: 4500 Travis- Water Infiltration Investigation
Houston, Texas
Building Diagnostics Project No. 842-3905-AOI

CONCLUSIONS

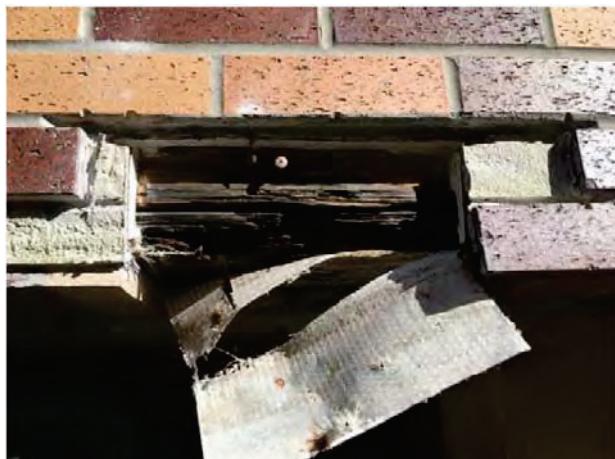
Figure 10.

We excavated the stucco at the lower offset and found water-damaged wood framing in the concealed cavity. This water appears to be permeating the stucco and becoming trapped at the change in plane because of the lack of a drip screed.

We excavated the TBV and stucco at the head of Unit 2229. We observed water-damaged wood framing in the concealed cavity. This water appears to be permeating the TBV and stucco and becoming trapped at the change in plane because of the lack of a drip screed.

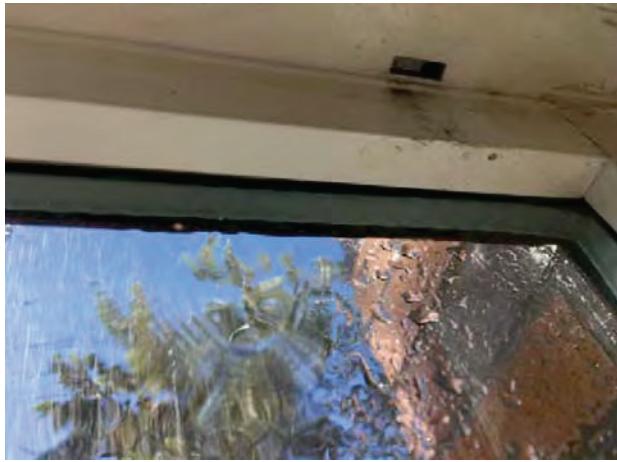
Figure 11.

The window assemblies contain a weep from the intermediate horizontal rail that is inside the window glazing. Window systems typically direct water from the glazing cavity to the exterior of the building. Here, water drips from the weep and splashes out of the sill extrusion at the bottom of the window.

We observed this manufacturing defect during our earlier studies. In 2016, the manufacturer installed pre-formed seals over some of these weeps, but the work was not comprehensive. We observed no seals at the window weep covers in Unit 2229.

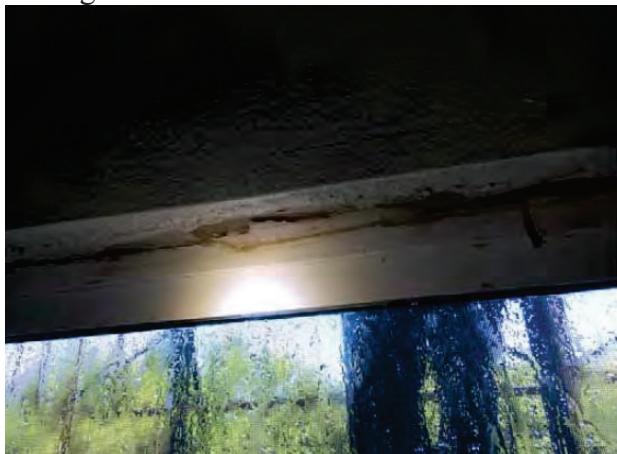
Figure 13.

We reproduced leakage at Unit 2243 by water testing in general conformance with ASTM E2128. We directed water at the spandrel area and sill of the 3rd floor windows.

We reproduced leaks at observed distress at the window head within 2 minutes of testing.

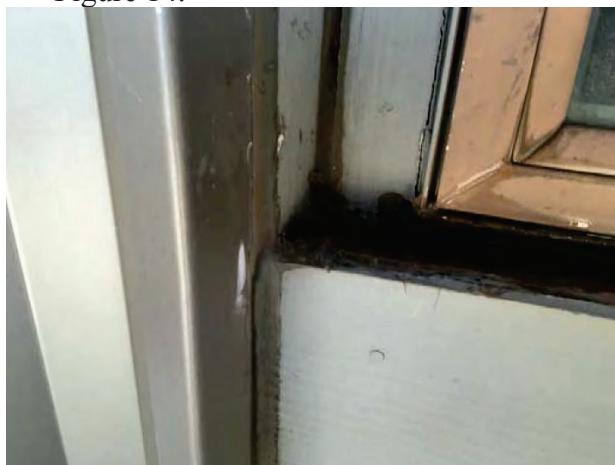
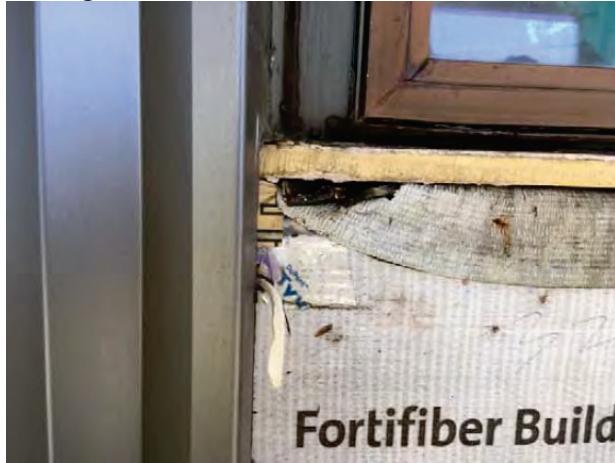
TSMR's Detail 15/A8.8 shows the sill of the 3rd floor windows, above Unit 2243. The cladding at this location consists of fiber cement board (FCB) siding, not the aluminum composite panels shown in the detail.

We observed the as-built sill projection to contain unsealed joints. We observed failed sealant at the corners.

We removed the panel to observe the concealed wall conditions. We found wrinkles and tears in the water-resistant barrier (WRB), consistent with our 2018 study. We observed water-damaged wood through the holes in the WRB. In our opinion, these conditions represent construction defects and resultant damage.

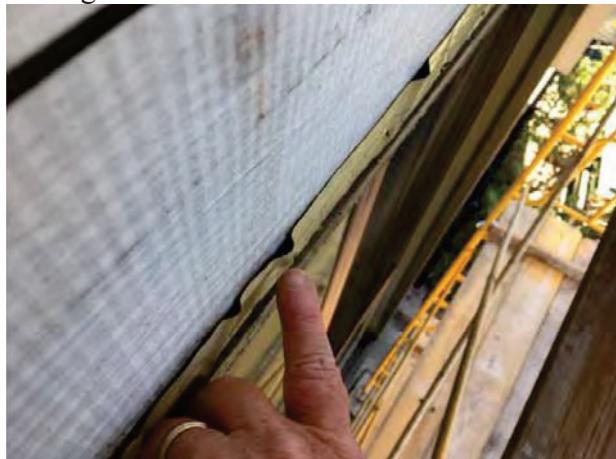
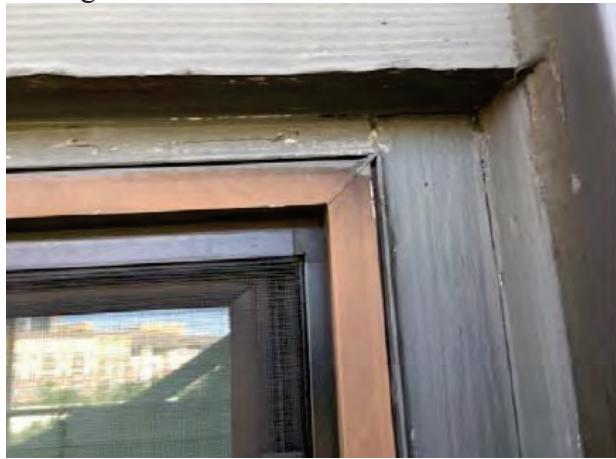
TSMR's Detail 14/A8.8 shows the head of the 2nd floor windows, at Unit 2243. The cladding at this location consists of FCB siding, not the aluminum composite panels shown in the detail.

We observed the window head flashing to be reverse-lapped and to contain "fishmouths" of un-adhered and wrinkled membrane that allow water to migrate behind the WRB. In our opinion, these conditions represent construction defects.

No weeps were installed above the window head.

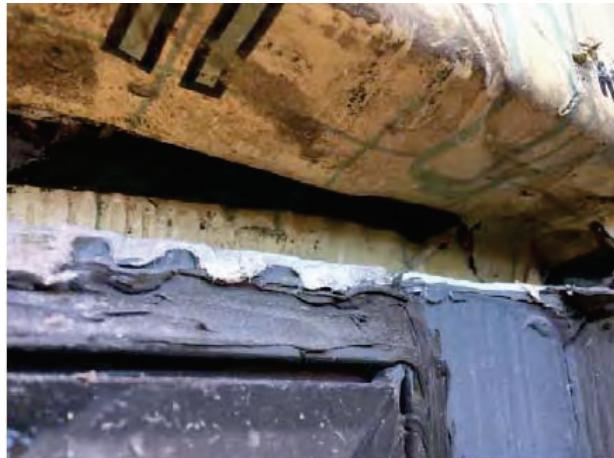
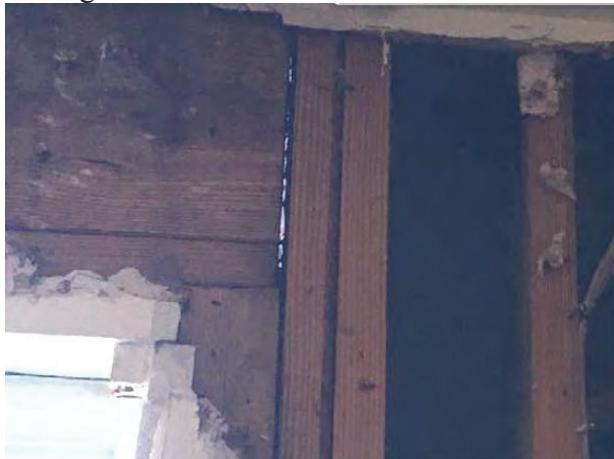
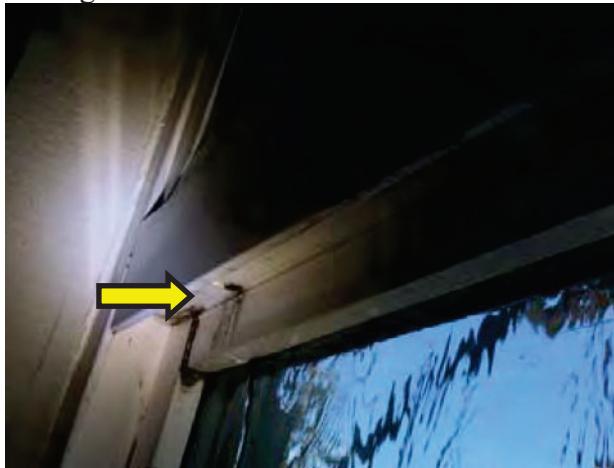
We observed the window head flashing was cut and separated, with a gap at the back corner. In our opinion, these conditions represent construction defects.

We observed the pre-formed seals at the interior weep below the intermediate horizontal mullion. This seal was not effective in blocking water from dripping during the water test.

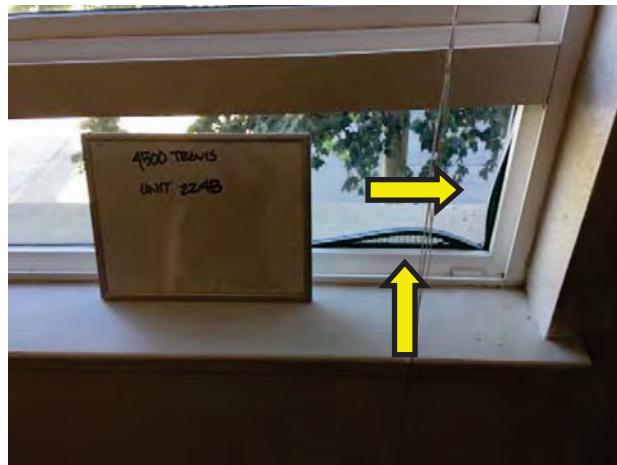
Figure 25.

This photograph shows the window sill of Unit 2248.

The IGU spacer has failed and bowed inward (arrows). In our opinion, this represents a manufacturing defect of the window assembly and their supplied IGU.

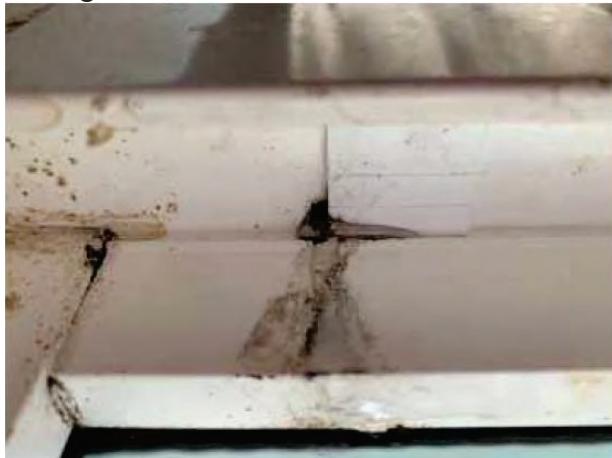
Figure 28.

The window of Unit 3336 is circled.

We observed the pre-formed seals at the interior weep below the intermediate horizontal mullion. This seal was not effective in blocking water from dripping during the water test.

At approximately 10 minutes into the testing, water began dripping from the Unit 3336 south window jamb and the window head.

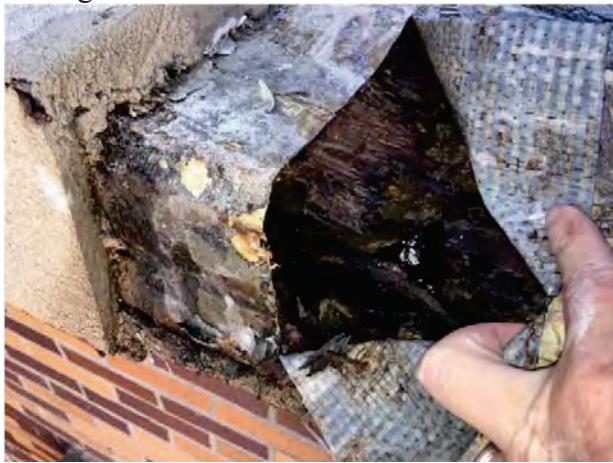
Figure 31.

This photograph shows the window sill of Unit 4336.

We observed no slope or shim in the structure below the self-adhered membrane and no drip screed at the outer lower edge of the stucco extension. In our opinion, these deviations from the design are construction defects.

Water-damaged wood was found in the excavation.

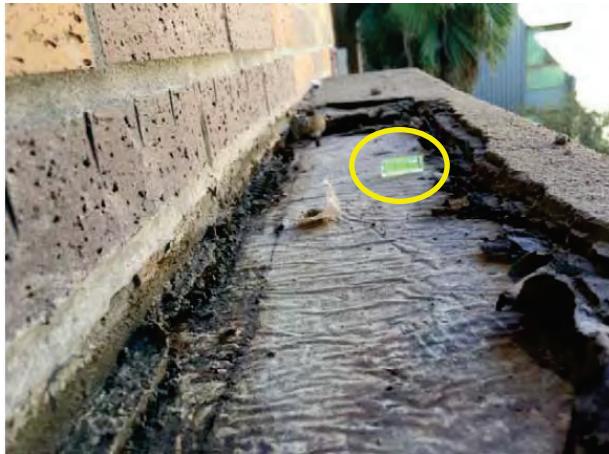
Figure 35.

This spirit level shows the stucco band sloping toward the building. As water migrates through the stucco, it will become trapped on the self-adhered membrane, eventually resulting in water seepage⁶.

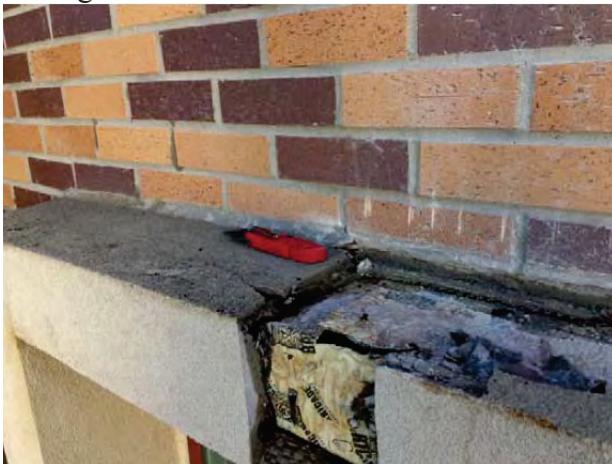
Figure 36.

We observed no drip screed in the outer edge of the stucco band and no weeps in the base of the TBV above the stucco band. We observed a fillet bead of sealant between the TBV and the stucco band.

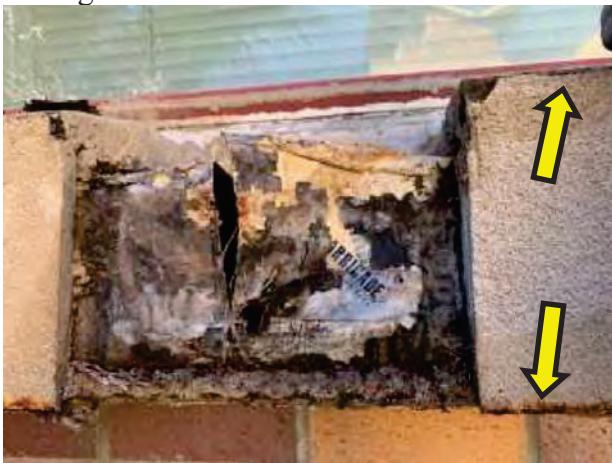
Figure 37.

We observed rust stains on the top and bottom of the ledge outer edges indicating corrosion of the metal lath from moisture trapped within the stucco.

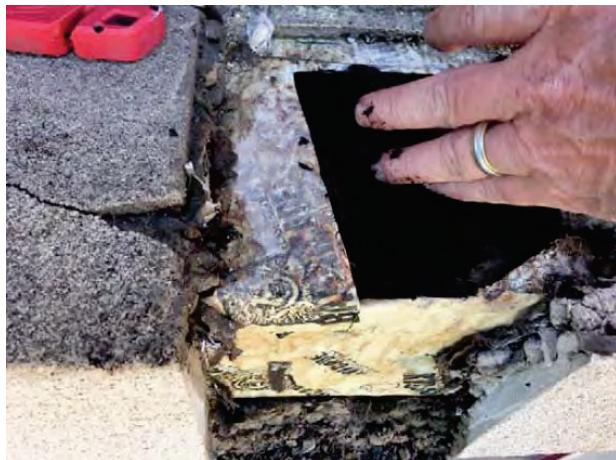
Figure 38.

We observed rotten wood behind the stucco band at the 3rd floor head.

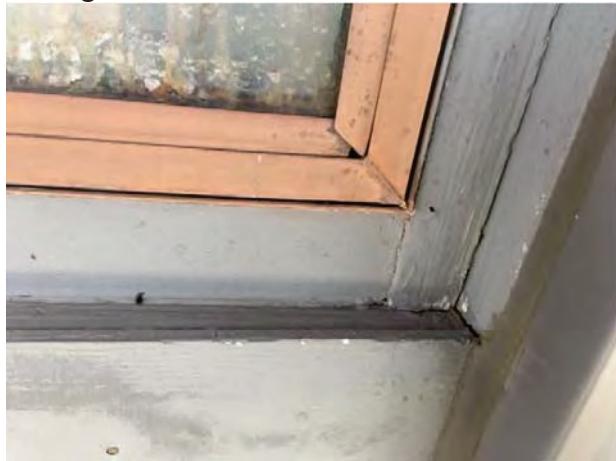
Figure 39.

We observed numerous areas of failed and unsealed joints between wall cladding materials. Many of the joints are too narrow to seal and do not comply with TMSR's Drawings for joint width. Undersized joints contribute to premature failure by not accommodating joint movement.

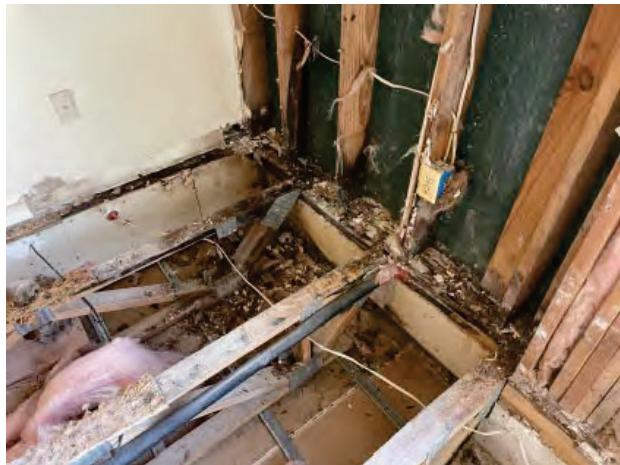
Photograph No. 1.

Additional water damage has been discovered at the interiors of Units 2239, 3339, and 4439 (Stack 39). The investigation of leak source(s) is ongoing. Portions of the floor truss top chord, wood studs and floor plates at these units have deteriorated and require repair before installation of the decking, wall, and finishes. The replacement of damaged stud framing will require that portions of the exterior wall cladding be demolished and reconstructed for this stack.
